Geotechnical Investigation

356 Lake Pty Ltd

Proposed Residential Subdivision

Lot 101 #356 Lake Rd, Champion Lakes, WA.

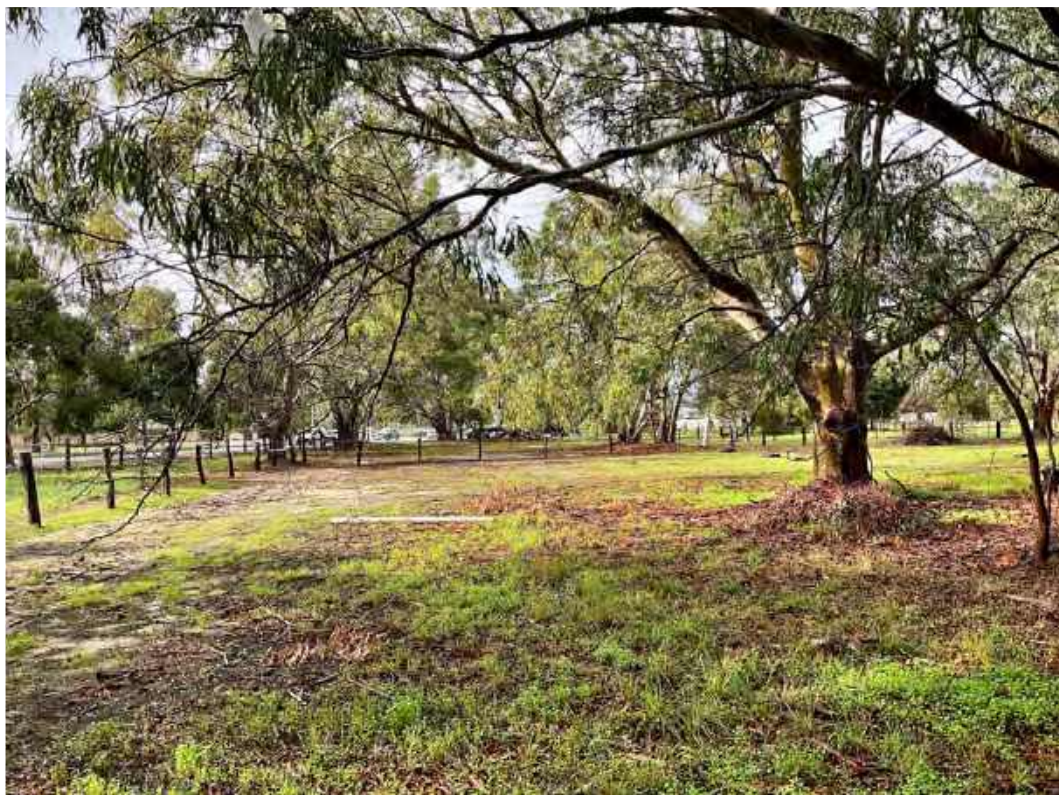
PHOTO 1 - Facing south towards BH2 from BH1 location

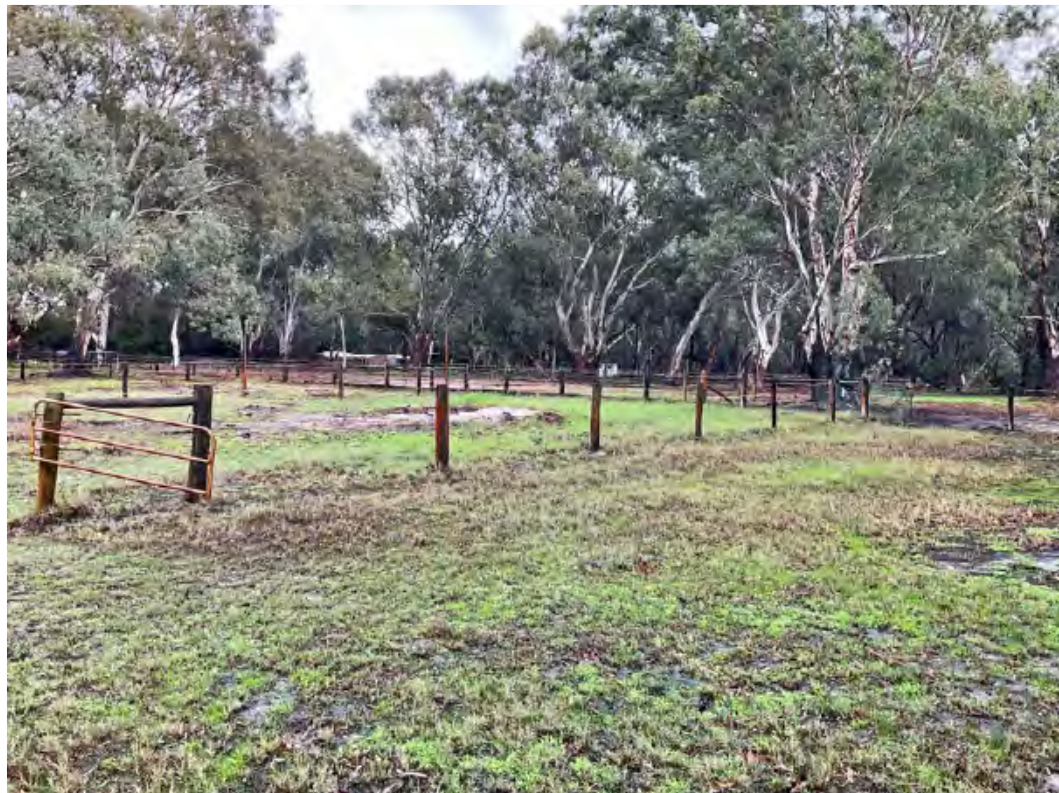
PHOTO 2 - Facing northwest towards BH3 from BH2 location

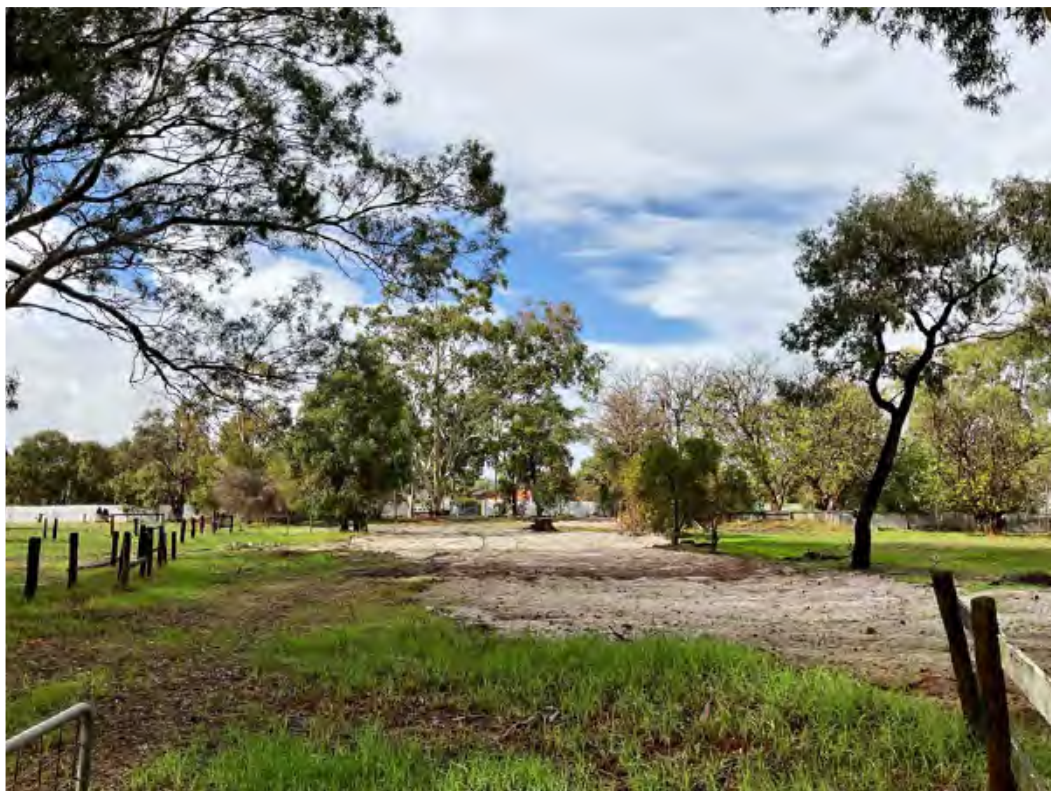
PHOTO 3 - Facing southeast towards BH8 from BH5 location

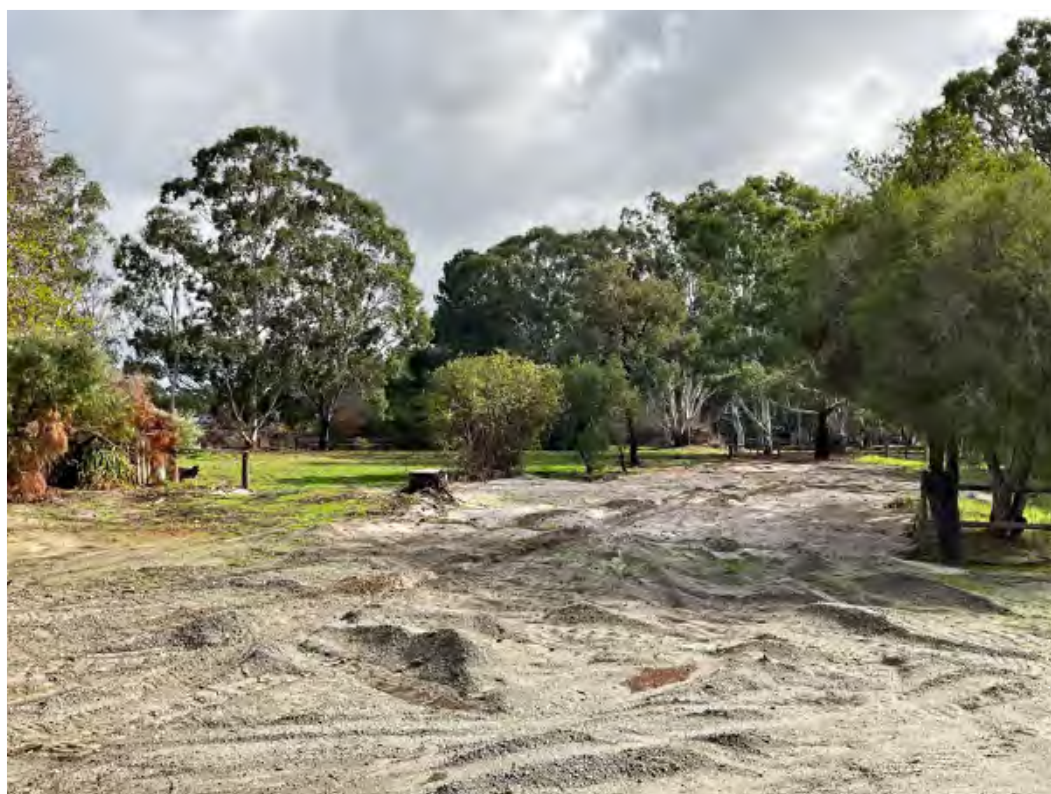
PHOTO 4 - Facing west towards BH6 location from BH8 location

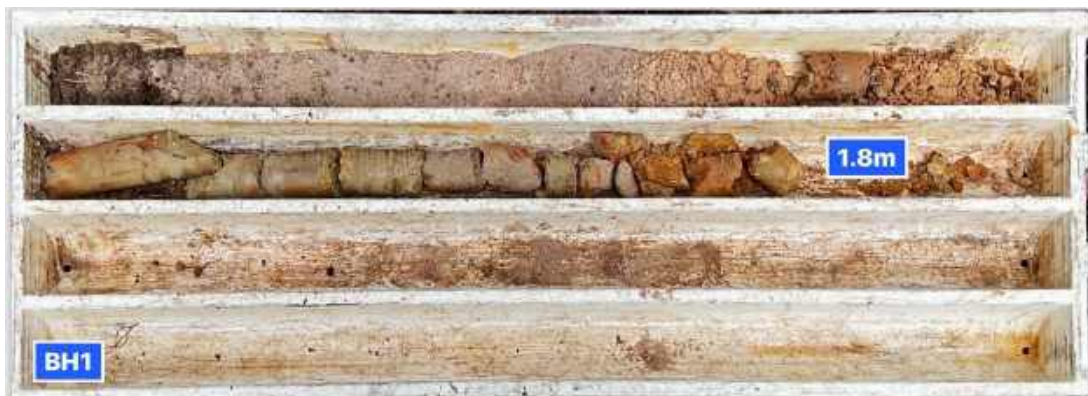
Water	Depth (m)	Soil Origin	Graphic Log	USCS	Material Description	Moisture	Consistency	PSP	Percolation (m/day)	Samples
		Non-soil		TS	Topsoil.					
		Natural		SP	Sand (SP): medium dense, poorly graded, medium grained, pale brown, dry.	D	MD		Percolation 1.9	
	1			SC	Clayey SAND (SC): medium dense, medium plasticity, medium grained sand, trace gravel, brown and pale grey.		F			
					BH01 Refusal at 1.4m (gravel refusal)

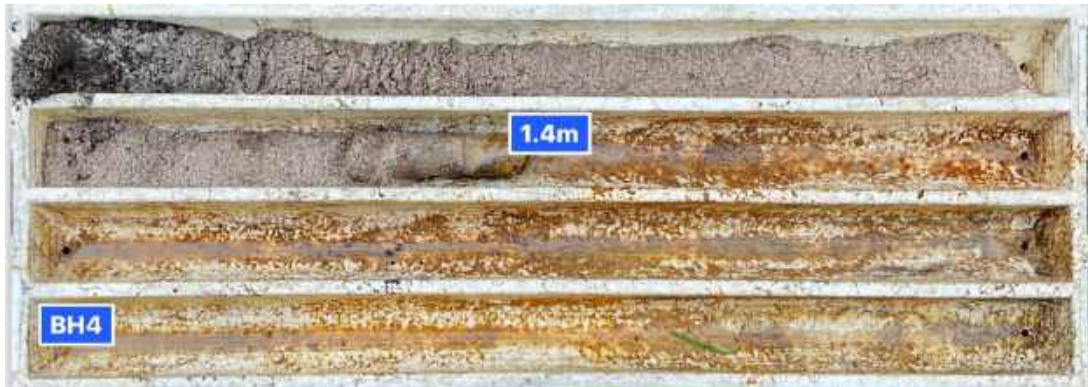
Water	Depth (m)	Soil Origin	Graphic Log	USCS	Material Description	Moisture	Consistency	PSP	Percolation (m/day)	Samples
		Non-soil		TS	Topsoil.			4		
		Natural		SP	Sand (SP): medium dense, poorly graded, medium grained, pale grey, moist.	M	MD	5	Percolation 2.4	
	1			SC	Clayey SAND (SC): medium dense, medium plasticity, trace gravel, pale brown and yellow.		F	4		
					BH04 Refusal at 1.4m (Clay refusal)			4

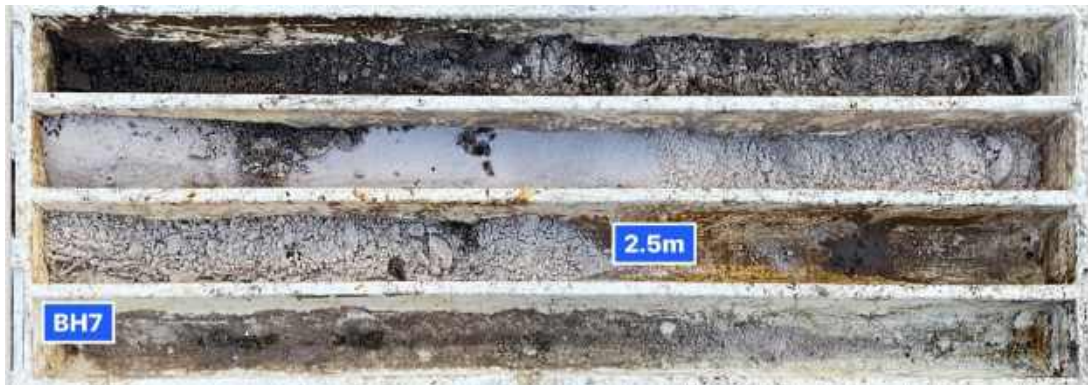
Water	Depth (m)	Soil Origin	Graphic Log	USCS	Material Description	Moisture	Consistency	PSP	Percolation (m/day)	Samples	
											0
		Non-soil		TS	Topsoil.			3			
	1	Natural		SP	Sand (SP): medium dense, poorly graded, medium grained, grey, moist.	M	MD	4			
	2			SP	Sand (SP): medium dense, poorly graded, medium grained, pale grey, moist.	M	MD	6			
					BH07 Terminated at 2.5m (target depth)

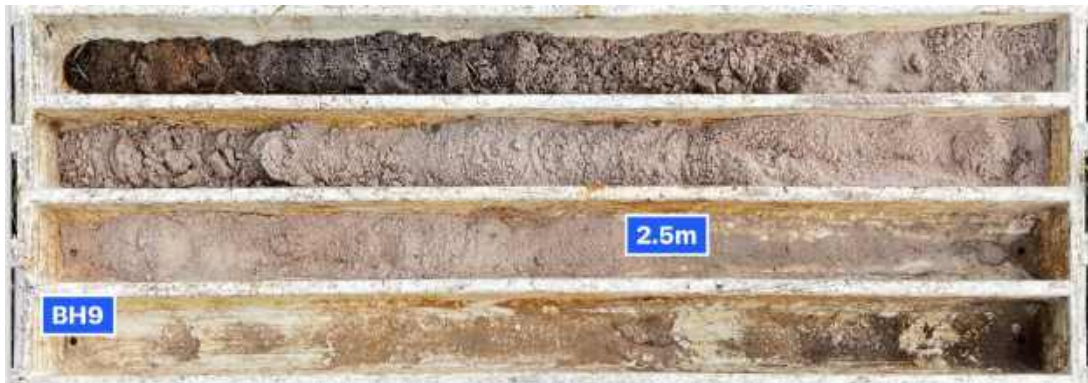
Water	Depth (m)	Soil Origin	Graphic Log	USCS	Material Description	Moisture	Consistency	PSP	Percolation (m/day)	Samples
		Non-soil		TS	Topsoil.			2		
		Natural		SP	Sand (SP): poorly graded, medium grained, grey, moist.	M		2		
	1			SP	Sand (SP): medium dense, poorly graded, medium grained, pale grey, moist.			3	Percolation 11.6	
	2			SP		M	MD	4		
								4		
								5		
BH09 Terminated at 2.5m (target depth)

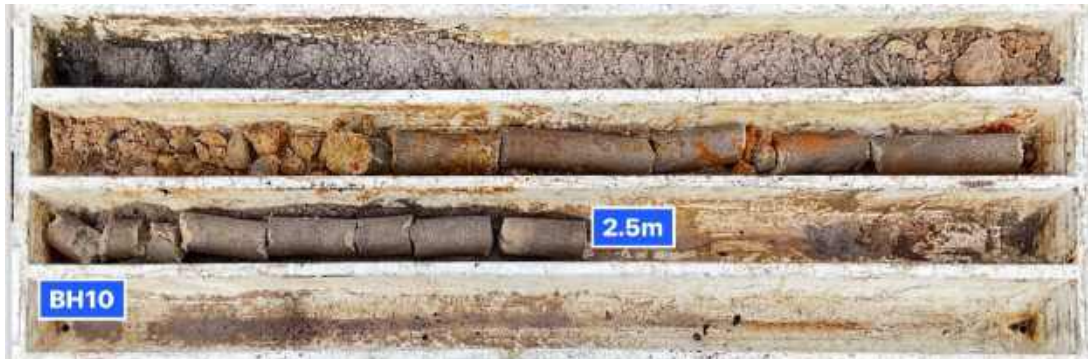
Water	Depth (m)	Soil Origin	Graphic Log	USCS	Material Description	Moisture	Consistency	PSP		Percolation (m/day)	Samples
								0	5		
		Non-soil		TS	Topsoil.			2			
		Natural		SP	Sand (SP): medium dense, poorly graded, medium grained, pale grey, moist.	M	MD	2			
	1			SC	Clayey Sand (SC): medium dense, poorly graded, medium grained, pale brown, moist.	M	MD	4		Percolation 1.6	
	2			SC	Clayey SAND (SC): medium dense, medium, medium grained sand, trace gravel, pale yellow and pale grey.		F	7			
					BH10 Terminated at 2.5m (target depth)
